WSSN: 04580

Office of Drinking Water and Municipal Assistance Grand Rapids District Office

# **Water System Sanitary Survey** City of Muskegon Heights Water System 2015

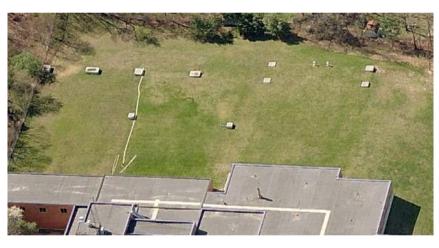
Comments on Settling Basins:
The additional basins have spread the flow and reduced levels of accumulated sludge to allow for easier removal.
Basins 1-4 were inspected by Dixon Engineering in 2009. Repairs to the basin interiors were made, but surface drainage must still be addressed to prevent ponding on the basin roof.
2014 - An additional drainage line should be added to prevent ponding against the building.
Water from 3 separate settled water lines is run to a single turbidimeter to determine settled water turbidity.

No.	Cat	Concern	Finding	Page
1	TR	Install additional drainage control for the building near the floc/sed basins	DEF	18
2		Repair packing gland in LSP #3	REC	16
3	TR	Adjust/repair packing on rapid mix #1	REC	17
4	TR	Repair bearings on rapid mix #2	REC	17, 39
5	TR	Top-off anthracite in filters 1-8	REC	21
6	TR	Install manual startup controls for chemical feeds due to part-time plant operation	REC	40
7	SC	Install additional raw water meter to provide flexibility with rapid mix units	REC	17
8	TR	Establish a filter maintenance program and secure necessary tools	REC	21, 39
9	TR	Check bed expansion during backwash periodically	REC	21, 39
10	MR	Conduct crypto sampling for round 2 of LT2 starting in Oct. 2016	REC	10, 36
11	PU	Establish a comprehensive preventative maintenance program for all pumps	REC	38
12	SC	Develop surface water intake protection plan	REC	11, 37
13	TR	Adopt water quality goals for the WTP	REC	10, 21, 42

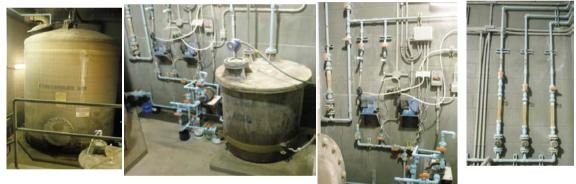
Fluoride: Bulk Tank, Day Tank & Transfer Piping, Feed Pump, Feed Points

Fluoride Comments:

- A transfer pump has been added to allow the bulk tank to supply the day tank when the bulk tank level is lower than the day A transfer pump has been added to anow the bank to tank.
Both Storage and Day Tanks have low level alarms
There is a sump alarm in the floor sump

Eyewash is usually refilled annually
 2015 - The bulk tank was leaking at the outlet flange, and had been out of service for several months. The fluoride was working again as of May 2015.

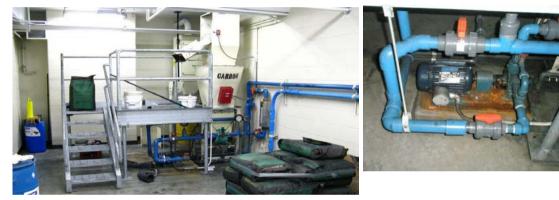
Carbon Feed Pump

Comments on Carbon:

Carbon is used intermittenly for taste and odor control in summer months as needed.
Carbon was temporarily being fed from a tank in the Alum room using one of the alum feed pumps. This equipment has now been removed from the Alum room. The carbon feeder had an oversized screw pump in the dry hopper, but a new screw of the appropriate size has been installed. The feeder is now available for use as necessary.
Typically, carbon will be fed in early May at a low rate to capture the entire seasonal algal bloom.

The water plant continues to maintain a carbon feed system which is only used to control taste and odor problems when necessary. The carbon is stored in 40 pound bags in the feeder room and approximately 2 dozen bags are kept on site. A volumetric feeder is used to put the carbon into a slurry and a small centrifugal pump is used to transport the solution. The carbon slurry is injected into each of the 2 raw water intake lines.

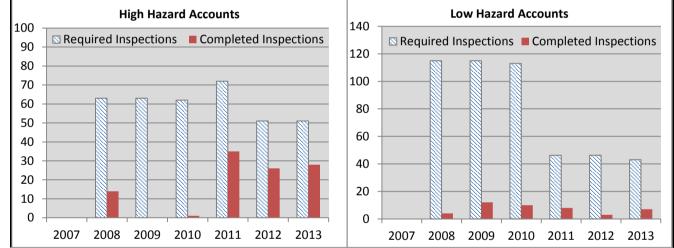
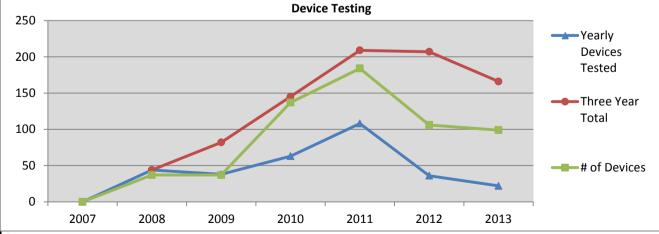
Cr	oss Co	onnectio	n Progra	ams			
	2007	2008	2009	2010	2011	2012	2013	2014
Total No. Accts								
High Hazard		63	63	62	72	51	51	
Low Hazard		345	345	339	139	139	129	
Years between inspections	report							report
High Hazard	not	1	1	1	1	1	1	not
Low Hazard	submitted	3	3	3	3	3	3	submitted
Inspection Required								
High Hazard	-	63	63	62	72	51	51	
Low Hazard	-	115	115	113	46	46	43	
Inspection Completed								
High Hazard	-	14	0	1	35	26	28	
Low Hazard	-	4	12	10	8	3	7	
Cross Connections Found	-	29	15	35	16	9	16	
Devices in System	-	37	37	137	184	106	99	
Devices Tested	-	44	38	63	108	36	22	
3-year Testing Total		44	82	145	209	207	166

Comments:

The supply has been behind in inspections for several years. Records for the inspections completed are <u>not</u> <u>adequate</u>. Devices tested are adequate, meeting the minimum 3-year testing frequency. All accounts are non-residential - the supply must begin documenting residential hazards. 2014 report is missing.
